Coal transfer facility fire at Taichung power plant-A case study

Abstract

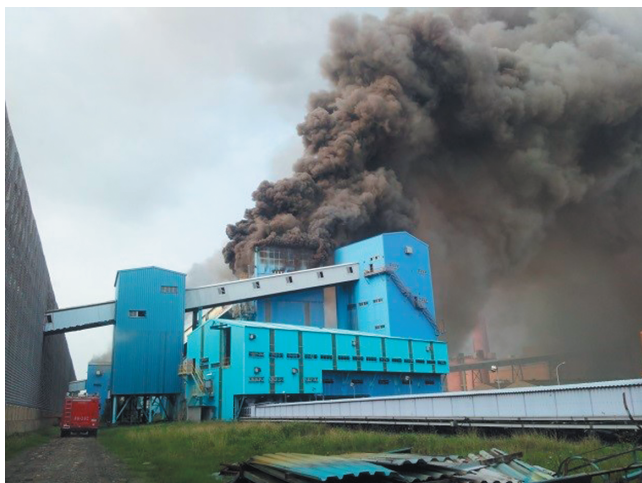
When first responders arrived, tower TR9 burst out with a large amount of smoke overhead, as shown in Figure 3. The fire impact area from TR9 to the

Figure 3 Tower TR9 smoke overhead while the fire service was on scene.

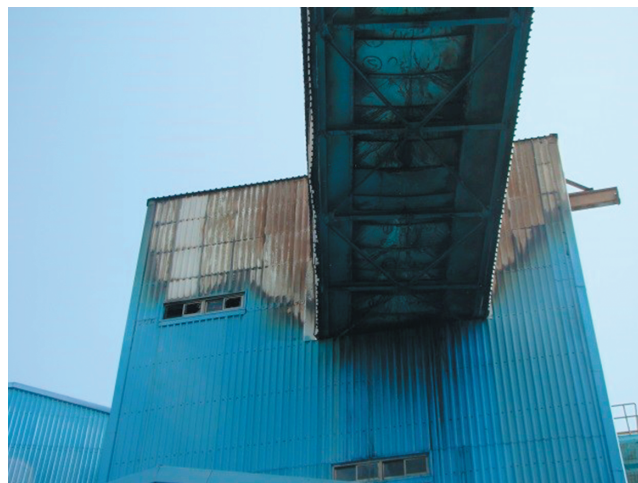
Figure 5 Tower TR9 showing discoloration.

Fire investigation on transfer tower TR9, with metal heat discoloration growing close to TR8 (Figure 5), indicated that the C23 conveyor tunnel sheet metal was discolored and bent from the heat (Figure 6). Above the weighbridge was the serious part of the fire destruction.

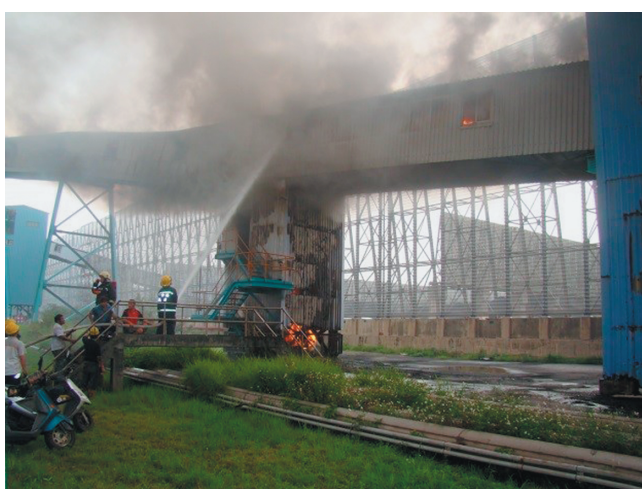
Figure 4 Weighbridge in full blaze.

weighbridge structure is shown in Figure 4. The conveyor ramp from north to south has an average height of approximately 20 m; in addition, there was considerable smoke and flame, with falling fly ash with smell of burning coal and rubber. Both sides of the enclosed conveyor and TR9 tower windows showed opened.

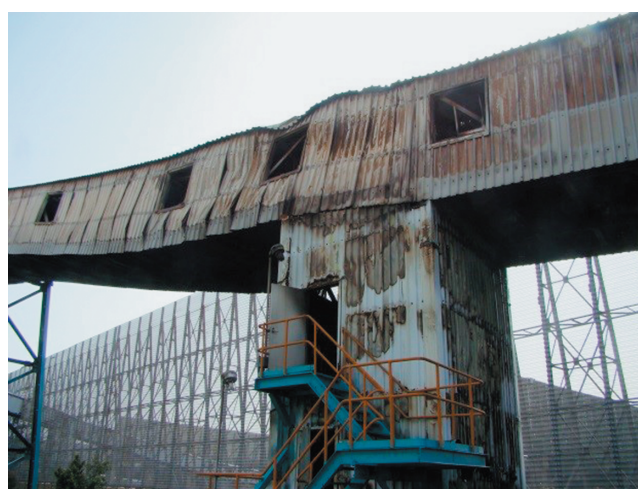
Figure 6 Weighbridge bending from the heat.

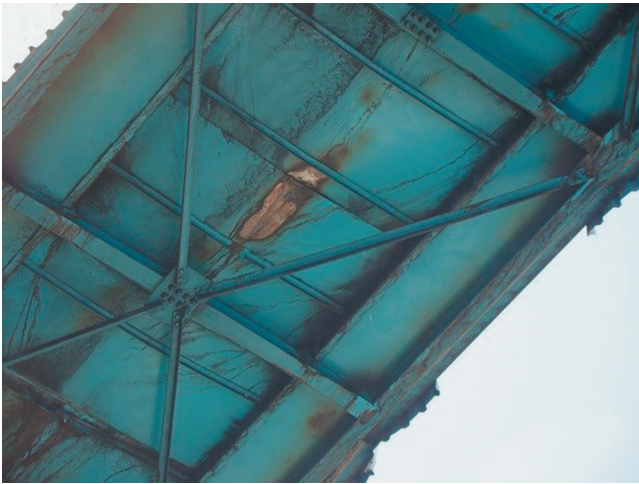
Between the fourth and fifth windows on C23 conveyor tunnel, sheet metal fell off discolored and bent due to the heat. The bottom of the conveyor showed yellow-white discoloration after being heated, as shown in Figure 7. To clean up the conveyor tunnel on TR9 side at about 20 m, a through cut of the lower belt wire was made to remove the accumulation of coal and wash the floor process. It unveiled 1.0 m long, 0.3 m wide of heat discoloration traces as shown in Figure 8. By observing the position of the conveyor tunnel floor heat discoloration, it can be confirmed that it was the only spot where sheet metal fell off.

Figure 7 On tower TR9 side at the range of 19.0–20.0 m (outside).

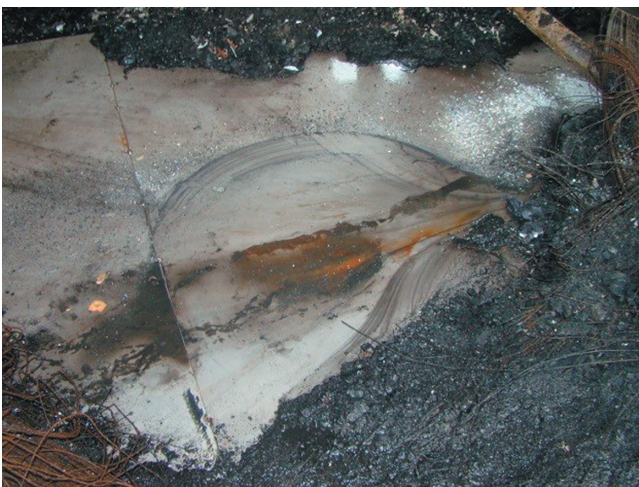
Figure 8 On tower TR9 side at the range of 19.0–20.0 m (inside).

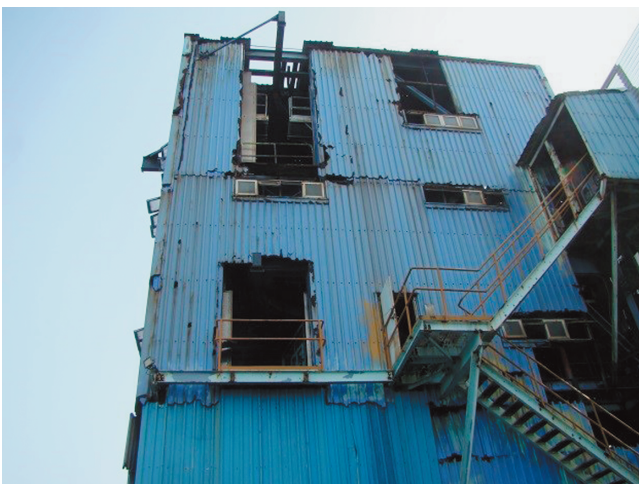
Figure 9 shows that there was no trace of heat on the tower TR8 surface. Therefore, the second floor of tower TR8 was where the broken conveyor belt slipped beneath the pulley, and a large amount of coal accumulation was found around the transit facility, upper layer, and conveyor support frame, as demonstrated in Figure 10.

Figure 9 Tower TR8 no heat trace on north side.

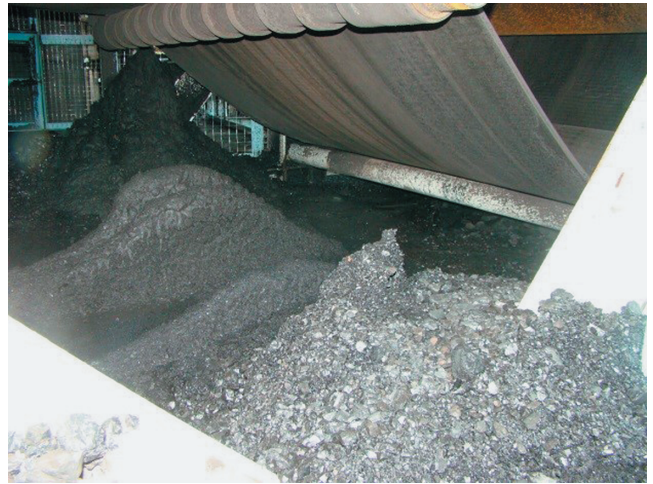
Figure 10 Coal accumulation around transport facilities.

The conveyor tunnel on TR9 side was at about 20 m, the auxiliary conveyor belt rollers leaned north; the top roller bearings were heated and bent more than others. The conveyor system found coal accumulation around the floor and upper roller bearings. According to the staff statements, the conveyor system had been shut down at 23:00. The malfunction of bearings of rollers supporting the belt might have run hot, with coal accumulation of contact with the surrounding parts which might have produced easy heat accumulation.

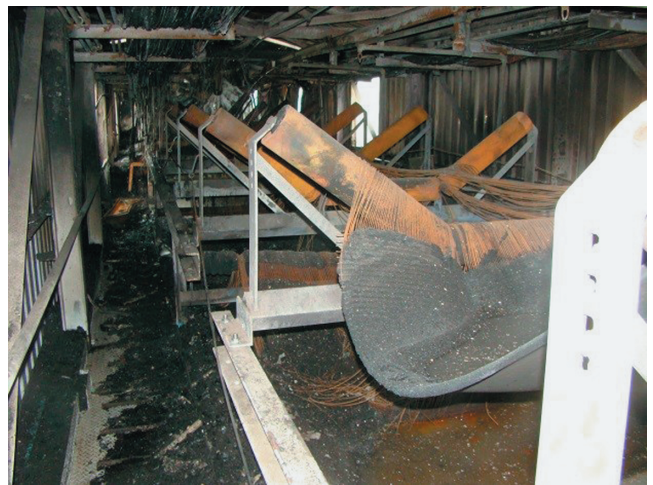
Figure 11 Broken conveyor belt slipped.

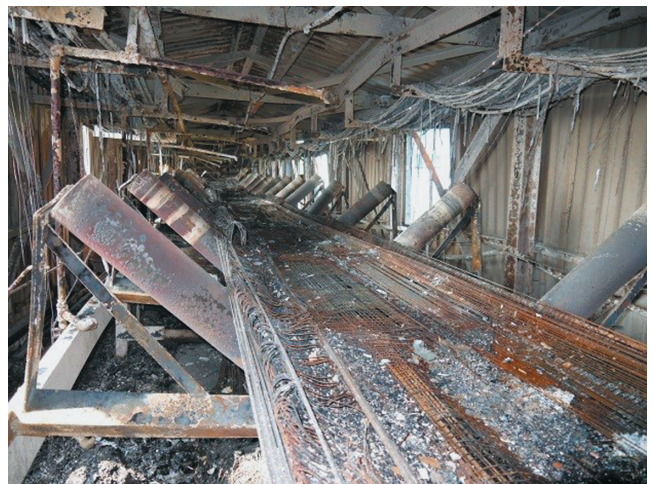
Figure 12 Conveyor belt remains.

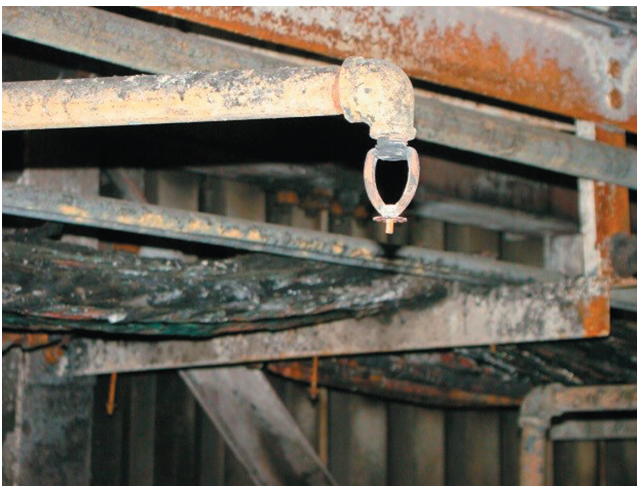
Figure 17 Damaged sprinkler after fire.

The enclosed conveyor tunnel had temperature sensor cables and sprinkler sensors. Meanwhile, when the fire occurred, temperature sensor cables and sprinkler sensors were active but not useful, due to maintenance on the fiber-reinforced plastic pipeline line. The deluge water spray

system was shut down temporarily. Although the deluge water spray system was opened immediately, due to leaking pipes and lack of water pressure, it still could not suppress the fire.
