The fireworks disaster in enschede

Part 1: Overview and reconstruction

J. Weerheijm *, R.M.M van Wees *, P.C.A.M. de Bruyn **, and J.W. Karelse**

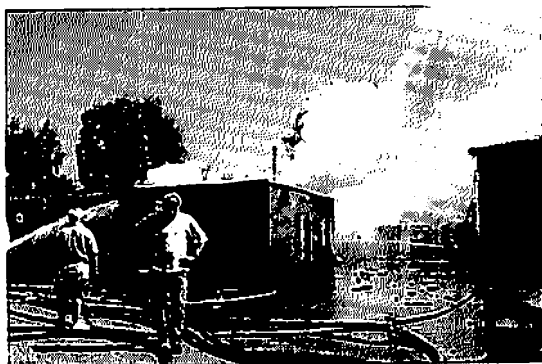
Fig. 2a Situation at 15.16 hours and Fig. 2b the escalation between 15.24 and 15.33 hours (pictures R. van Willegen)

The figures 2^a and 2^b illustrate the situation and the escalation of the firework reactions in the period of 15.16-15.33 hours. The pictures of Fig. 3 show the final explosion (from a distance of about 600 m) and a top view of the explosion area with search sections taped out for the forensic investigation. The detailed time scheme and extensive event and damage descriptions are given in Weerheijm⁶⁾. In this paper only the headlines are given.

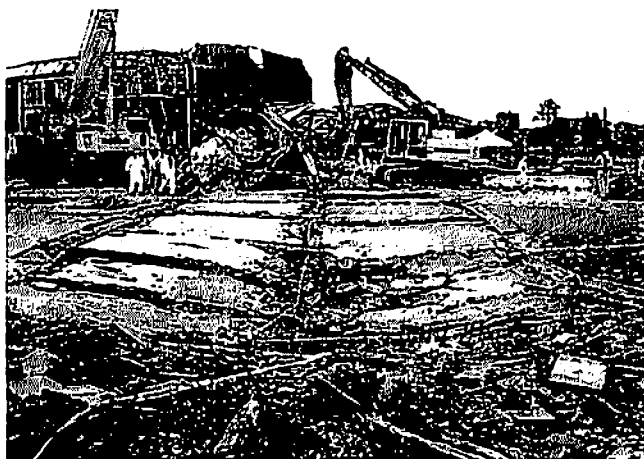
Fig. 4 Damage central building

- In C11 a crater was formed with a depth of 1.3 m. The crater extended to the other cells and was clearly the result of one explosion event;

- the floors of the other cells show no damage of independent, severe explosion reactions, only the edges of the cell floors adjacent to C11 are severely damaged and contribute to the crater (see Fig. 4)
- the remaining reinforcement stubs of the floor-wall connections of all cells show deflection directed away from cell C11;

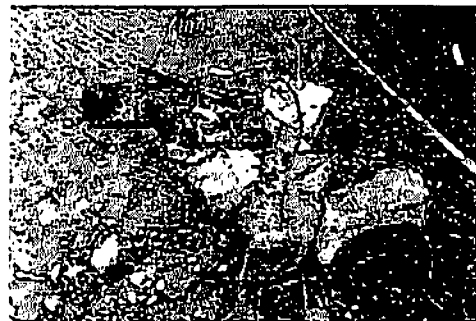
Fig. 5 Debris at 165 m

Debris from the central building caused many casualties and severe damage to buildings. Debris was found up to a distance of 580 meter. (see Fig. 5). The angle of impact, the throw distance of the major debris was related to the "required" launch velocity. Because the launch angle is unknown, only an approximate range of launch velocities could be determined. Most of the collected debris had a launch velocity in the range 30 – 100 m/s. Maximum reconstructed velocity was 150 m/s. Please note that most of the debris that could be collected was most probably not from C11 or the adjacent cells, because these were broken in small pieces due to the high explosion pressures in the cells.

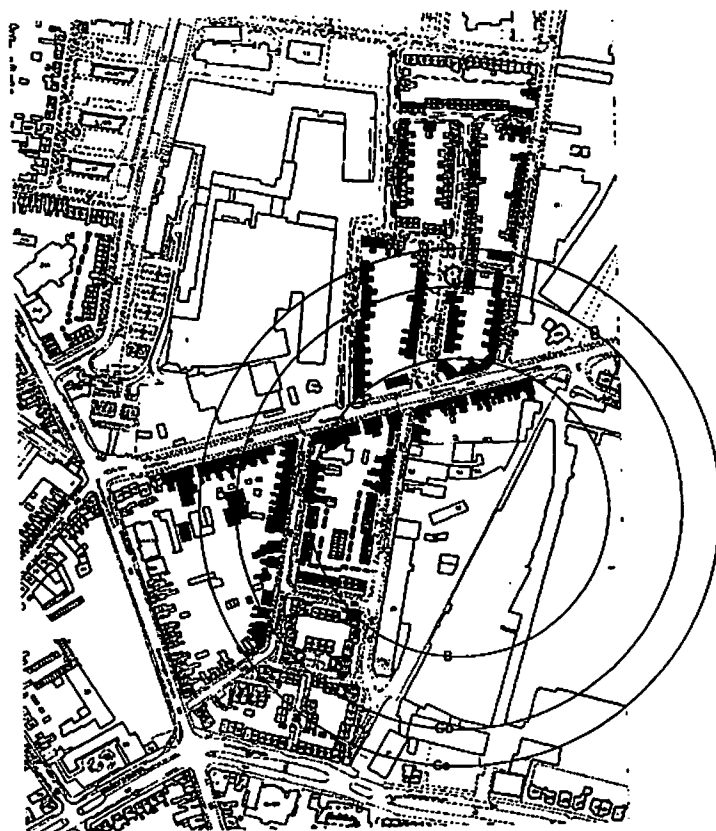
Fig. 6 Damage radii

second World war II and are commonly accepted. The zones are given in Fig. 6 with the radius for damage level Ca is about 230 m.

The final, devastating explosion proved to be in the range of 4000-5000 kg TNT equivalence. The size of the fireball was 135 m, corresponding to 86.500 kg propellant. It is evident that that these effects are not caused by the contents of cell C11 alone. Sympathetic reactions of the other cells and also the containers contributed to the observed effects. On the video recordings the shape of the fireball shows clearly some additional "sub-sources" which may be caused by container reactions.
