Fly-rock incidents by blasting at three quarries

Katsumi Noguchi

Explosives Research Laboratories, Blasting Divisions, Nippon Kayaku Co., LTD, 2300, Ooaza Koori Asa-Gun, Yamaguchi-ken 757-8686, JAPAN
e-mail: katsumi.noguchi@nipponkayaku.co.jp

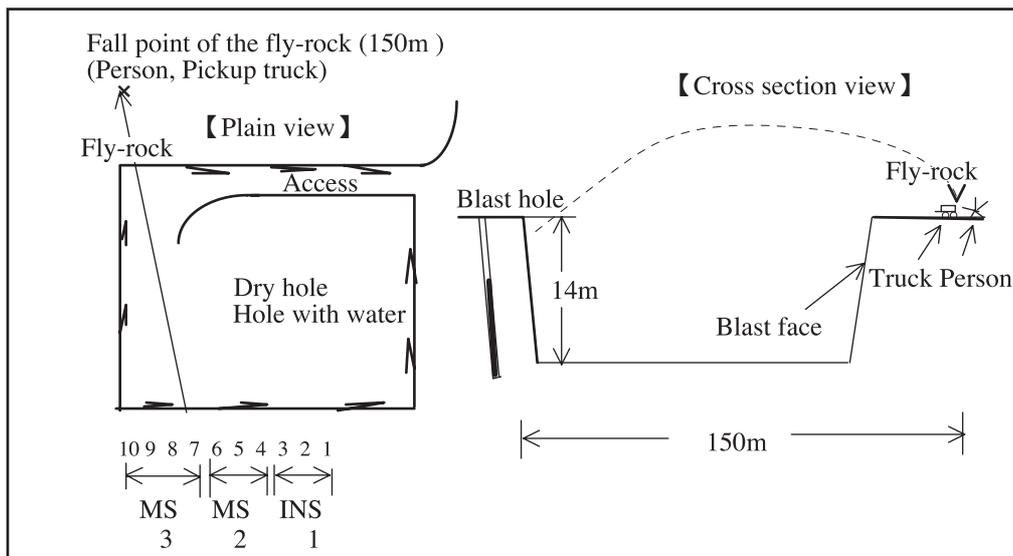
Fig. 1 Fall point of the fly-rock and blast site (A quarry).

On August 23, 1997, when blasting (type of blasting: face blasting with down hole, total charge; 310kg, hole numbers; 10 holes, millisecond delay detonator; delay number 1, 3, 5) was done, some fly-rocks struck a person (involved in blasting work) on the thigh and a pickup truck (load capacity: 500Kg) thereby. The person was standing ahead on the slant from the blast face then. His left thigh was seriously fractured by some fist-sized lump rock. Some lump rocks flew also into the pickup truck and damaged seriously to the truck body and its inside. Both the person and the nearby pickup truck were located about 150m away from the blast site. (Fig. 1)

Most fragments were piling up within the range of approximately 20-30m ahead of the bench face, while small size fragments (nearly 10-20cm) were scattering far (to a distance

of approximately 60-70m) over an area where the fragments were piling up especially ahead of No.7-No.8 hole. (Fig. 1) On the left-hand face, many joints developing in every direction were exposed.

As indicated above, the specific charge on calculation for the basic blasting design that had been adopted on this site is considered not so large from the rock quality there. Therefore, at the time, the round does not seem to have been of overcharge all over. However, as long as seen from the appearance on the site that many small pieces of rock was scattered quite to a long distance ahead of the right side of blast site, some shot-hole within the area will probably have become of over-charge.

- Burden diminishing in part due to drilling deviation.
- Burden diminishing in part due to irregularity of blast face.
- Elevation of a charge head in the hole with water that led to lacking of the length in stemming owing to failure of settling down of explosive cartridges and etc..
- Existence of extremely soft materials or high frequent joints developing locally on the blast site.
- Existence of some disturbed or extremely soft material which is not exposed on the surface

However, a certain position in front of the blast face at which the victim was evacuating is regarded as be on a major direction of rock movement under blasting. The position seems never suitable for evacuating. One of the greatest causes for the fly-rock incident seems a human-induced miss on direction and distance to the evacuation position. If there is no appropriate position to look out on the site, a reasonable means such as a heavy-duty shelter, etc. will be to be brought in for protection to the fly-rock.

- To make clear the geometry of the blast site by removing any loose rock completely.
- To check up carefully the on site condition such as some asperity on the blast face as well as a local variation in rock quality such as some local disturbed zone with an extremely soft material or with quite dense joints.
- To estimate any variation in the rock quality inside the ground that is not exposed on the surface, checking carefully the cuttings (e.g. color, hardness and grain size, etc.) and the drilling performance (e.g. drilling rate) .
- To ensure a given stemming length by checking careful-

ly the space remaining within hole under loading with explosive cartridges. Especially, that will be important in case of the hole with water or with rugged wall.

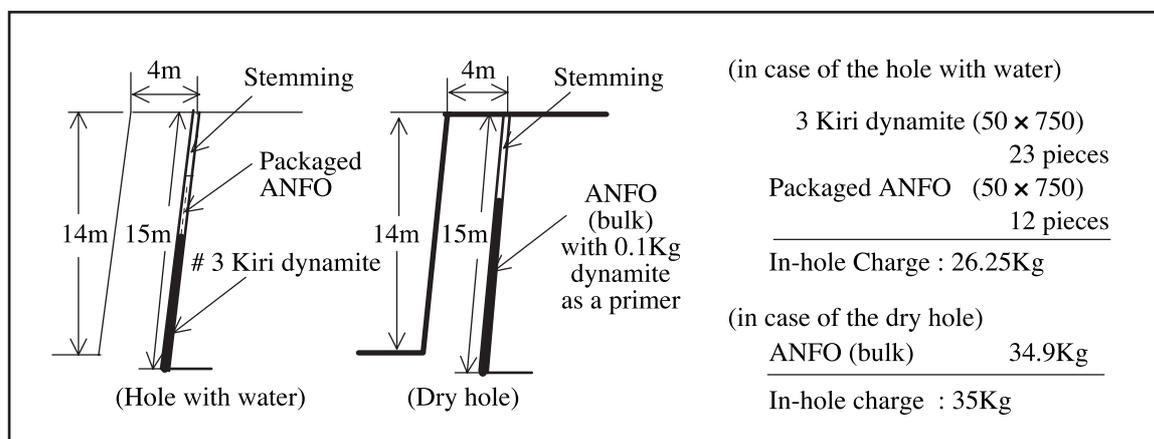
Fig. 2 Schematic representation of charging in the holes with water and dry hole (A quarry).

In case of the hole filled with water (Fig. 2), calculating from the following length of a given explosive cartridge used, stemming length become nearly 3m, and in case of the dry hole (Fig. 2), calculating from the bulk density (0.85g/cc), that hole become nearly 5m.

In case of the latter, the ratio (1.25) on calculation seems appropriate in contrast to the common ratio. Meanwhile, in case of the earlier, that on calculation becomes 0.75times of the burden, which seems too short. (Fig. 2) However, if the hole has only a little water at bottom, the cartridge in hole will probably be shrunk as much as in case of the dry hole by load from the upper part. In case of the dynamite cartridge used there, the charge can be expected to shorten substantially by load from the upper part although its degree varies by the number of cartridges commensurate with the length of hole. (But the upper portion of ANFO cartridge seems hardly shortened.)(* Assuming that the charge portion with dynamite only is shortened fifteen percents, the in-hole charge length will be decreased from

In contrast, in case of the hole with so much water to overflow out of the hole and or with water at least to a extent that all cartridges hide in water after charging with, the charge length will become as calculated based to each cartridge length that is approximately equal to the sum of length in respective portions of dynamite cartridges and ANFO cartridges and nearly 12m since both the portions are expected to hardly shorten by action of the buoyancy in water.

However, in actuality the amount of water contained within hole will differ from one hole to another, so the degree of shortening also will be changed with that. Therefore, it will be impossible to predict an exact charge length only by the number of cartridges in each hole and thus there will be no certainty to be able to hold an in-hole space required for a sufficient stemming anywhere. Furthermore, in such the hole with water, some cartridge will be likely caught on a rugged hole-wall and some small rock-piece loosing around a hole will drop down once in a while on in-hole bottom or cartridge pre-loaded under loading. Also such cases will result in going up of charge head and then falling short of required stemming length.

Therefore, all holes should be loaded with explosive cartridges, checking carefully in-hole space for sufficient stemming by loading stick with scale, etc. under loading. If it is judged by checking under loading that subsequent loading will make impossible to hold a certain stemming length required due to the reason as above, then further loading should be stopped. That should be performed to avoid scattering from the bench crest even if the specific charge becomes a little smaller due to that.

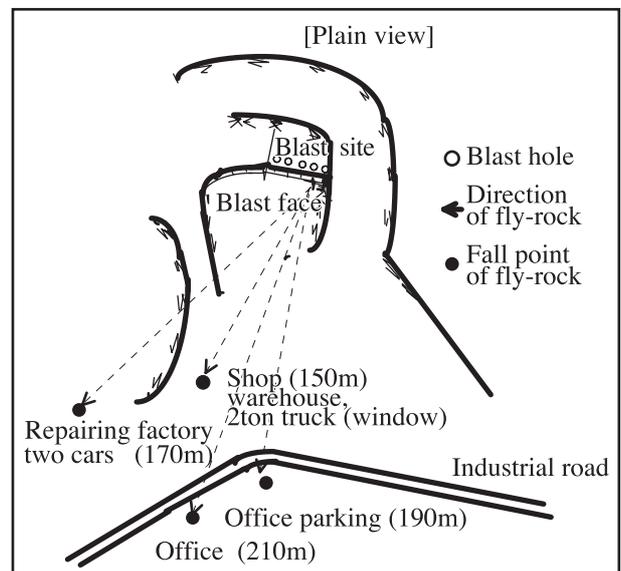
Fig. 3 Fall points of fly-rock and blast site (B quarry).

On July 10,1998,when a certain blasting was done, one fly-rock incidence occurred and at the time some pieces of rock damaged to the window glass or the body of four privately-own cars parking in the parking space of a company, the slate roof of a repairing factory and two privately-own cars parking there, and the window glass and the tank of a shop warehouse and the window glass of a 2T truck parking there. Distance from the blast site to those stricken properties ranged within approximately 160m to 210m. (Fig. 3)

In a region with No.1 to No.12 hole, the rock mass with hard and competent quality without appreciably joint was exposed on the face and the crest. Fragments piled up in an area of nearly 15-20m as usually ahead of the face in the region, leaving a clear wall. Meanwhile, in a region of No.13 to No.15, many rectangular fissures with some soft inclusion were exposed appreciably on the blast face as if many bricks were stacked there, leaving quite widely unclenched fractures in quite a number of them. Furthermore, a few large rock blocks (nearly 1m in size) rested just in front of the face and large rock lumps were left like plastering down on the face. And furthermore, a number of small rock lumps (nearly 10-15 cm in size) were scattered far (to a distance of approximately 50-60m) beyond there.

Seen from the local condition that the rock mass being disturbed appreciably on the right-hand face (No.13-No.15) as well as that of rock pieces scattering ahead of the face, it's more than probable that explosion gas together with some rock pieces in the vicinity will have blasted out through some widely unclenched fissure (or fracture). However, it will be able to be negated also that (1) there was a variation in minimum burden uncalculated on an uneven face if seen from such the on-site condition, (2) the stemming in some hole came short of length due to any of the reasons as described above, and or (3) such the region became what had a little over-charge if seen from the rock quality, etc.

- To carefully check the condition on blast site from all sides. Especially not to overlook any irregularity on the blast geometry such as an unevenness on the face, a dent of the face in front of the hole bottom and an chipping away of the crest, etc.. And to determine the burden and the hole-spacing or the hole-positions taking account of that.

- To pay attention to any change in the rock mass quality (such as existence of high frequent joints or fissures and soft or poor rock with weathering or faults), and to modify the drilling pattern.

- If there is some large void and some crush zone or soft material zone (running to the face) in the hole, to change the charging pattern into such the pattern as adopting stemming deck partially. Still to check carefully the performance and the aspect of cuttings under drilling in order to find out its position in hole.

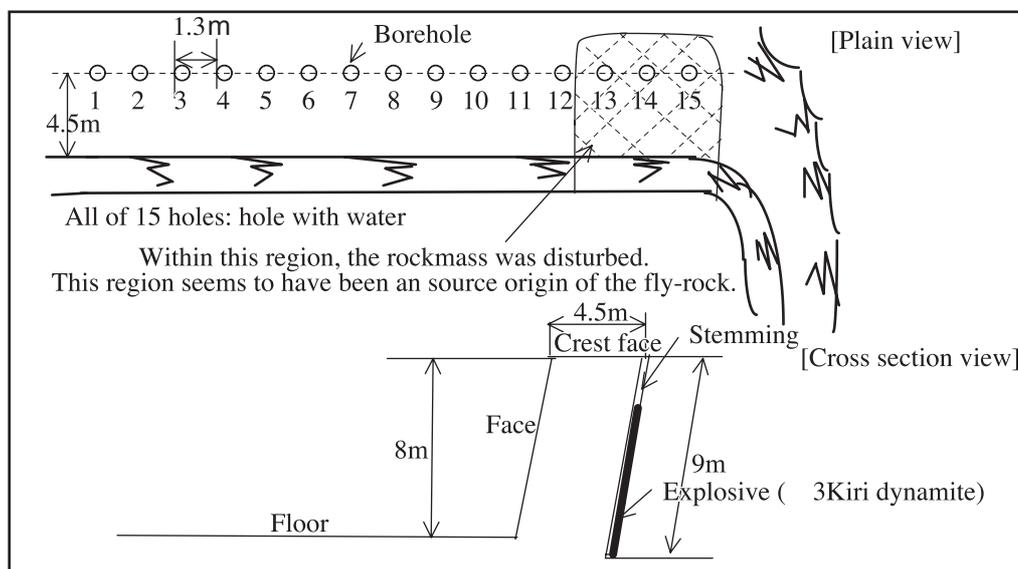
Fig. 4 Schematic representation of the blast pattern at B quarry.

Blasting was done by using the drilling pattern like the one at A quarry, but the burden was still more decreased than at A quarry. It seems that this is any more a pattern like the one when a dimension stone is quarried by using black powder, etc. Such the blasting is in nature what makes such the blocks thrust forward slowly and thus keeps the rock displacement to a minimum. Therefore, that is what has less possibility of fly-rock ahead of the bench. However, in reality, fly-rocks arose in the direction.

According to Olofsson³⁾, stemming/ burden ratio is 0.5-1.0, in order to give blockier fragment with an optimum blasting. The ratio at B quarry become about 0.29, that is quite small compared to the ratio. (At the quarry concerned, that is 0.625) However, there were a number of actual achievements (without fly-rock incident) that such the drilling pattern had been applied former repeatedly at the blasting site.

its cartridge length (31cm/piece), and thus the stemming length become nearly 3m. This stemming length seems too short compared to that applied in general bench blasting. The (stemming length/burden length) ratio is 1.0–1.65 commonly. Most commonly, it seems 1.0 or a little more. Incidentally, the ratio is $3\text{m}/4.5\text{m} = 0.65$ on calculation.

A loading test with explosive cartridge on the site after the incident found that the actual loading length with 20 pieces of cartridge in the case of hole filled fully with water approximately corresponded with a length calculated from the cartridge length and its numbers and thus in-hole charge length after loading was hardly decreased by the action of buoyancy in water. Meanwhile, that in the case of dry hole was decreased by 20 percent to that on calculation as above. It's more than probable that the loading condition in hole with a minimal amount of water at hole-bottom also is fairly same as that in a case of the dry hole. In that case, its length is assumed to be shortened from 6m to 5m and thus the stemming will become 4m in length which corresponds to (stemming length/ burden length) ratio = $4\text{m}/4.5\text{m} = 0.90$. The stemming length seems not so short although the ratio is under 1.0.

The problem will be in a case where hole is filled fully with water. If there is such a hole, then a required stemming length (at least 4m) should be kept by reducing some number of cartridges in hole. However, such a hole become of a little under-charge whereby, so it will be necessary for the burden or the spacing to be narrowed by just that much, but that will not be practical. If there is a concern about blowing out due to under-charge since the charge is twenty percents less in the hole, it will be able to be defused by making an stemming firmly with an appropriate material and a required length. Incidentally, stemming material used on the site was No. 7 crushed stone (2.5-5.0mm).

However, each hole on the blast site seems to have been what have more to less or a minimal water depending on one hole to another, and thus the charge and thus the stemming in loading with 20 pieces of dynamite cartridge seems to have varied in length depending on that. Therefore, it will be essential to check carefully the remaining hole-length

loading with the cartridge in order to keep a sufficient in-hole space required for a required stemming.

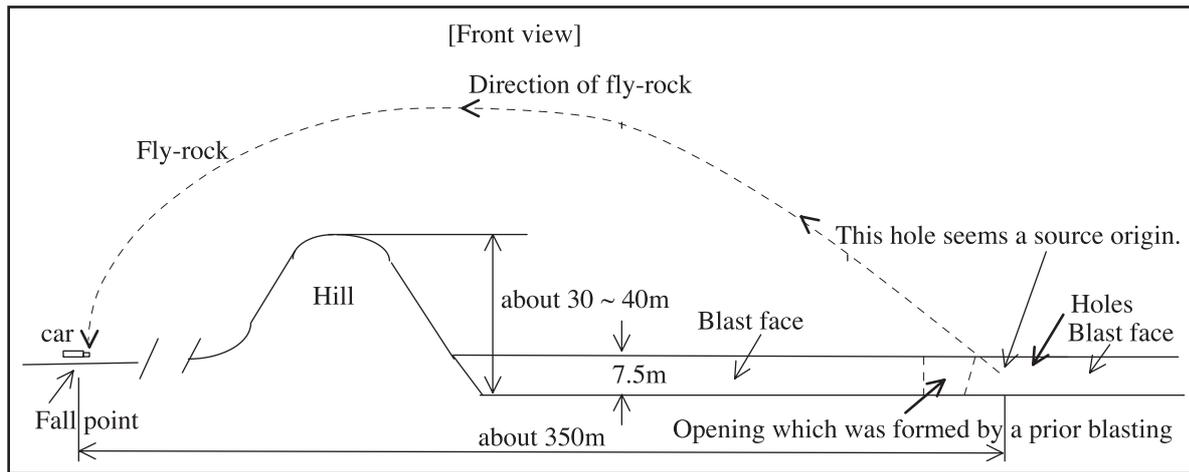
Fig. 5 Schematic representation of fall point and blast site (C Quarry).

On February 8, 1999, when blasting with holes cross the blast face (i.e. front face) was done by using DS detonators and # 3 Kiri dynamite (31.5kg), some rocks flew nearly 300m away in a left-hand direction of the blast site (or in a parallel direction to the face), and hit a company car, a factory employee under operating it within the factory site and the slate roof of a house within there. This incident at the quarry brought about the following damages. (Fig. 5)

- Human damage:
A piece of rock crashed through the front glass of a car and then it hit and rebounded upon a driver's door and fell on the right thigh of an employee under operating the car. The degree of injury of the person was a thigh contusion with the complete recovery ten days.
- Physical damage:
The front glass and the inner globe of driver's door suffer the damage by a piece of rock. And another piece of rock damaged also to a roof on the factory building. An opening (nearly 4cm) with crazing arose on the slate roof.

An observation on the site immediately after the blasting showed that on the whole rock hardly moved ahead of the blast face and only a small number of fragments piled up right in front of the face. However, a good many small-sized fragments (approximately 10-15cm in size) rested ahead of only the front face closed to the left-hand periphery with (# 1) instantaneous detonator, and a considerable part of the fragments got lying down quite far (to nearly 30m).

And, most holes on the right-hand face with DSD # 3, # 5 and # 9 left quite deep hole-butts. Many fractures also were exposed on the face and some of them were open widely enough to dig up easily by an excavator held in the quarry. And furthermore, it was found that there was a sharp change in rock quality within the region with # 1 holes and # 3 holes. There were less appreciable joints on a right-hand face to the boundary (# 3 side) but quite dense joints developing in every direction on the left hand.(# 1 side).

- To remove any loosened rock on the blast face (the lateral face as well as the front face) and to clear up the blast geometry thereby, and to fix an appropriate position of each hole on the basis.

- To carefully check the on-site condition if there is a sharp change in the rock quality or the geological condition on there.
- To fire mutually adjacent holes situated cross the boundary with an identical delay number of detonators, if there is an explicit boundary between a poor rock mass (i.e. extremely soft rock mass with dense joints etc.) and a hard rock mass on the blast site.

- To control each in-hole charge or hole spacing depending on the rock quality and the geological condition.
- To stem rigidly with a sufficient amount of stemming material so that in-hole charge may not be flicked out during a successive firing.

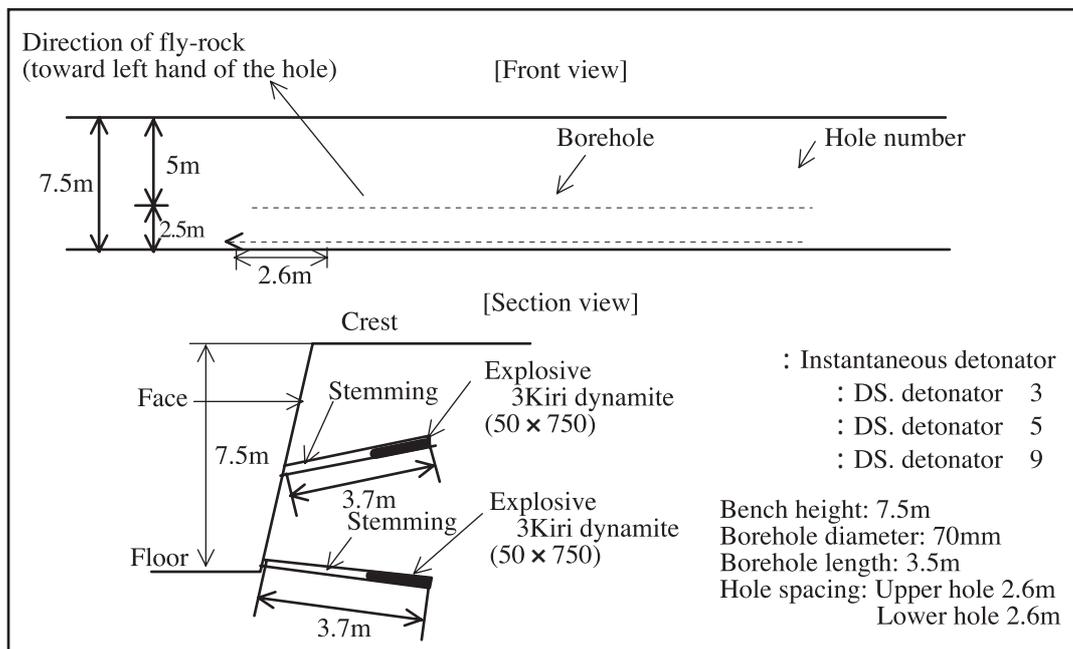
Fig. 6 Schematic representation of blasting pattern at C quarry.

Blasting type: blasting with holes cross the front face (i.e., collapse blasting), Type of rock: sand stone
 Face height: 7.5m, Hole diameter: 70mm,
 Hole diameter: 70mm, Burden to the front face: 3.3m,
 Hole length: (upper row) 3.7m, (lower row) 3.7m,
 Holes: 14 (upper row) 7holes, (lower row) 7holes
 Hole angle: 15°, 10° (respectively, an upper row and a lower row of holes)
 Explosive: # 3Kiri dynamite (50mm×750g) 31.5kg,
 Cartridge length: 30cm
 Detonator: Instantaneous detonator (# 1) 2 pieces,
 Decisecond detonator (# 3) 4 pieces,
 Deci second detonator (# 5) 4 pieces,
 Decisecond detonator (# 9) 4 pieces,
 Total 14 pieces

Each hole was charged with 3 pieces of #3Kiri dynamite cartridge and stemmed with PE packaged sand in the blasting. In this instance, it could be derived on the calculation from the cartridge length (0.31m/piece) that holes were charged with to 1/4 × hole depth (or 0.93m). In practice, it's inferable that the length became still shortened by tamping rigidly each cartridge within hole. This length is a little different from what have been recommended generally. (i.e., up to 1/3 × hole depth in case of dynamite), but rather seems appropriate on minimizing scattering of rock ahead of the face.

As described above, a sharp change in the quality of rock mass was seen on a boundary between a region with #1 holes and that with the other DS #3, # 5 and # 9 holes. That is, the rock mass in the earlier region was what has a soft quality with quite dense joints developing at short intervals in every direction, and on the contrary the rock mass in the latter region had a hard or competent quality without appreciable joint, and many hole-butts with some remarkable depth were left on the face and its depth was such that it proves a hard rock mass.

A blasting way that was applied under the incident was sort of a face blasting with two rows of holes cross the front face like so-called collapse blasting. The specific charge was 0.07kg/m³ on calculation that seems not too high but rather a little low in the right-hand region as long as seen from such the on-site condition. By nature, such the type of blasting is likely to propel a number of rock pieces ahead of the face. And, there will be also a great possibility that an explosion gas with some rock pieces blow out ahead of the face due to the under-charge unless a sufficient stemming is done there. Therefore, it will go without saying that great care is to be taken to the direction.

After two holes with instantaneous (# 1) detonator was fired, the rock mass in an region surrounding the holes was broken too broadly and then a minimum burden being developed in left-hand direction of hole with # 3 will have been decreased very greatly out of calculation. Alternatively, some fissure in the region may have been extended close to the hole with # 3 and it have been greatly open at that moment. And, when the holes with # 3 were fired, its explosion gas by firing of some hole with # 3 may have blasted out together with some rock-pieces through the fissure. Or, at that time, some cartridge (with detonator) may have been almost in the state like nakedness that led to open firing.
