Coal transfer facility fire at Taichung power plant-A case study

Abstract

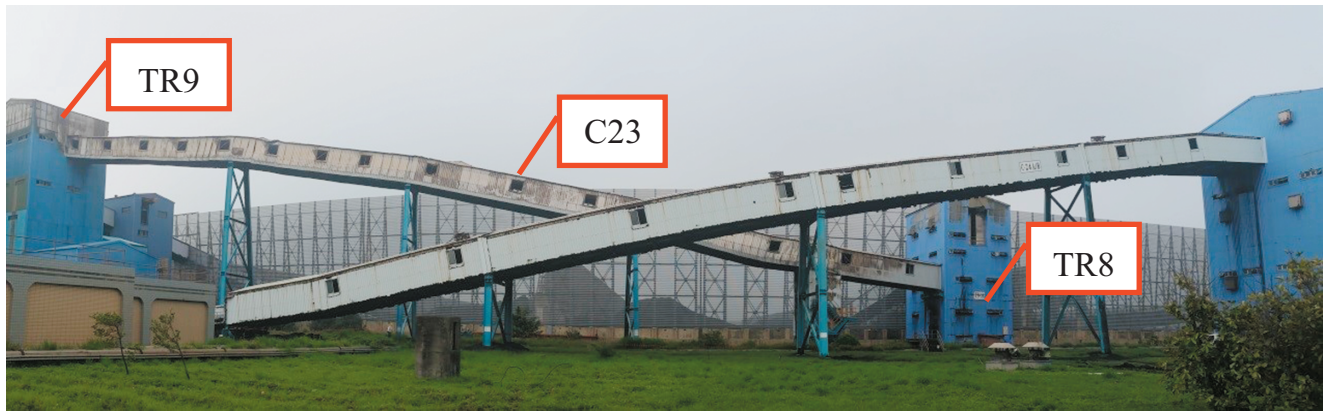
Figure 1 Layout of conveyor systems.

At 16:21 on May 28, 2014, information from Taichung Harbor Fire Brigade reached the Taichung power plant control center duty officer that the coal conveyor belt was on fire. The layout of the conveyor systems is shown in Figure 1. When the rescue vehicles arrived at the scene, TR9 transfer tower smoked overhead. C23 conveyor was connected to TR9 and TR8 transfer towers, and almost the entire coal conveyor-belt systems were in full blaze; especially, conveyor belt breakage fell above the weighbridge, with the fire burning fiercely focused on the bottom. After the fire was controlled, a 100m conveyor belt was damaged along with a burning area of about 400 m². Apart from the conveying equipment burning, the fire did not spread elsewhere, and no casualties were reported. The layout of the conveyor system fire is schematized in Figure 2.

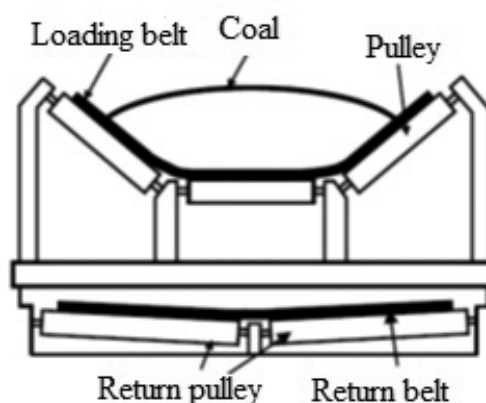
Figure13 Typical conveyor system.

Most conveyor belts are made of a synthetic resin or rubber (Figures 13 and 14), such as polyvinyl chloride (PVC), acetal compound ($R_2C(OR)_2$), polyethylene, and nylon. Although a conveyor belt has flame retardant properties, once a fire breaks out, the conveyor belt itself may contribute to the fire spread and even become a part of propagating of the flame along the belt surfaces.

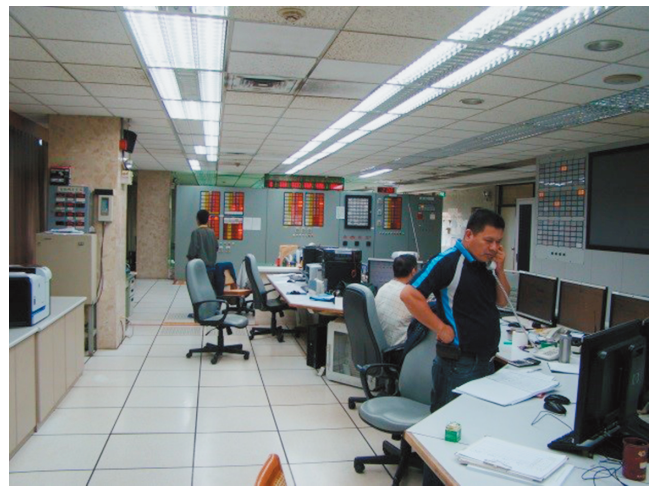
Figure 19 Control center in Taichung power plant.

Taichung power plant set up a coal storage control building to monitor the coal-related facilities operation (Figure 19). The seventh floor control center was staffed by two supervisors and two duty officers with three shifts. Furthermore, electrical equipment inspectors and mechanical equipment inspectors were responsible for the machinery and equipment around the plant. When the fire occurred, the fire alarm and fire extinguishing equipment, including both signals, were confirmed to be in action, as shown in Figure 20. After duty officers were informed of the fire, and confirmation was made through windows of TR9 transport tower smoke overhead, the fire department was quickly and timely notified.

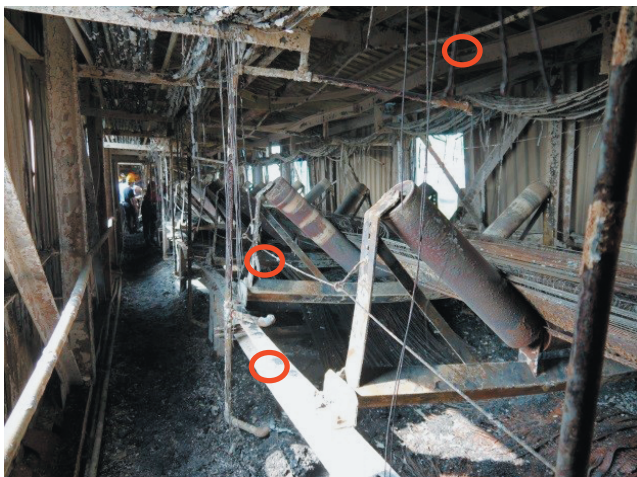
Figure 18 Layout of the sprinkler in Taichung power plant.

with a pitch of 45° to protect the bottom of the conveyor belt from fire, as shown in Figures 17 and 18.

$10.2 \text{ L m}^{-2} \text{ min}^{-1}$, the fire pump water flow is 1566.3 LPM. Automatic sprinkler protection is provided overhead along the center line of the belt with sprinkler spacing of 2.14 m.
