Application study of explosive demolition for the wall-slab building

Chul-Gi Suk*, Woo-Jin Jung*, Hyoung-Ki Park*, Nae-Hoi Kim*,
and Kunihisa Katsuyama**†

*Korea Kacoh Co., Ltd., Seoul, KOREA

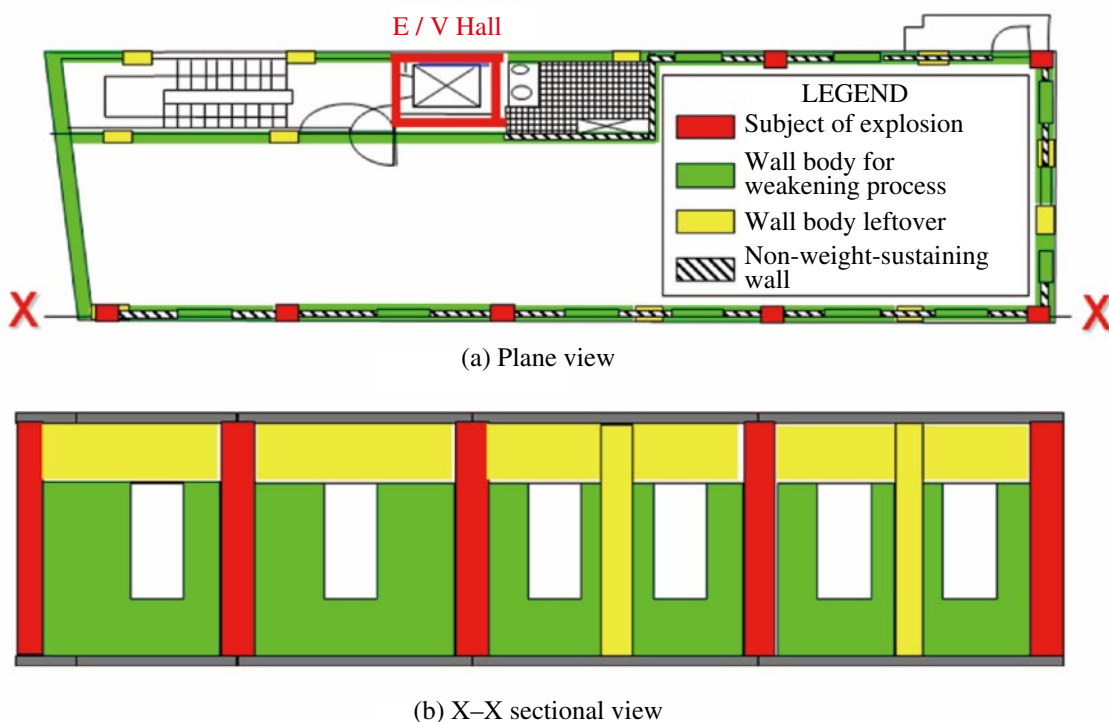
Fig. 3 The range of pre-weakening process and explosive demolition.

The pre-weakening process is carried out for 8 days using 015 B / H, human Breaker and a small-size cutter, and the range of the pre-weakening process is shown in Fig. 3 (a) and (b).

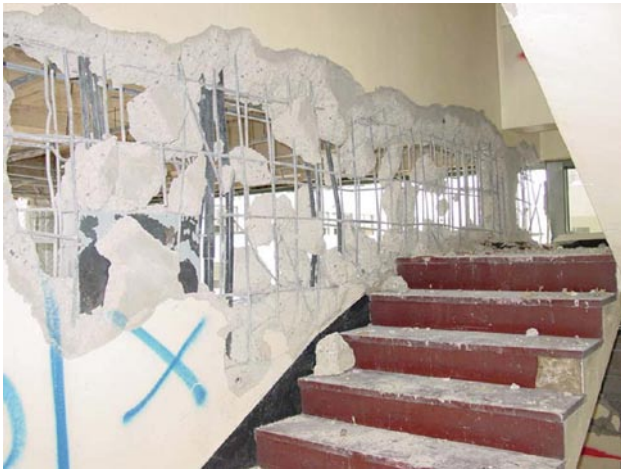
Fig. 4 Picture of the stairs room after weakening process.

The pre-weakening process for the stairs was undertaken as shown in Fig. 4. The inner parts of the stairs were broken using manpower and equipment.

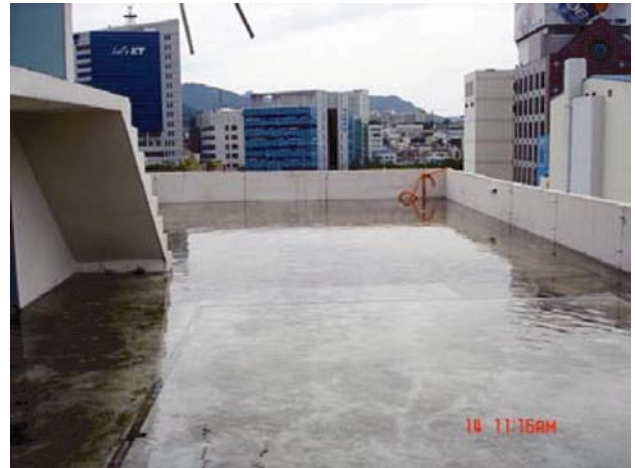
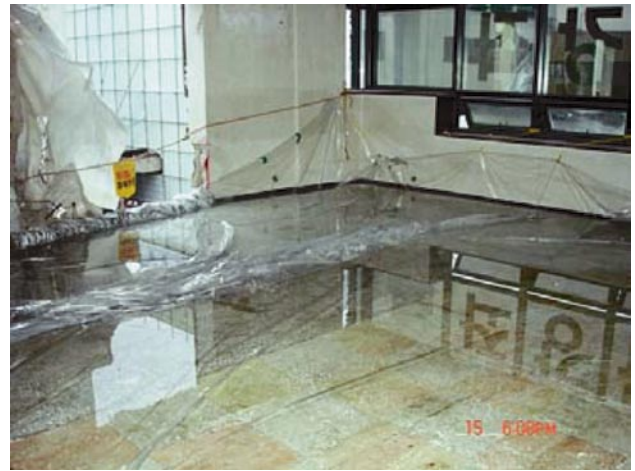
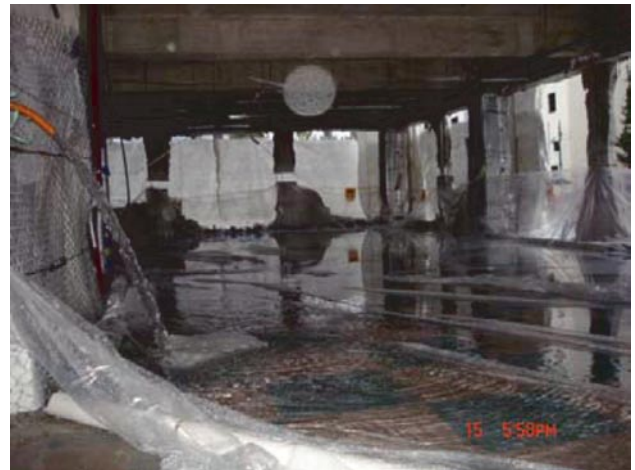
(a) Roof (40 ton of water)

(b) 3 F (20 ton of water)

(c) 1 F (20 ton of water)

Fig. 5 Installation of water in the vinyl sheets.

In order to constrain the dust which occurs during the blasting, vinyl sheet was installed at the 1 F, 3 F and the roof and after making the vinyl water proof, approximately 80 tons of water was filled into it as shown in Fig. 5. Hanhwa, Inc.'s non-electric detonation cap HiNEL Plus and gelatine dynamite MegaMITE 22 mm (D 25 mm × 220 mm × 125 g) were used as the explosives and were loaded at the pillar part. For wall bodies with a thickness of 300 mm, a 10 g m⁻¹ explosion inducing line HiCORD Plus 100 was loaded. The total amount of explosives used is listed in Table 1.

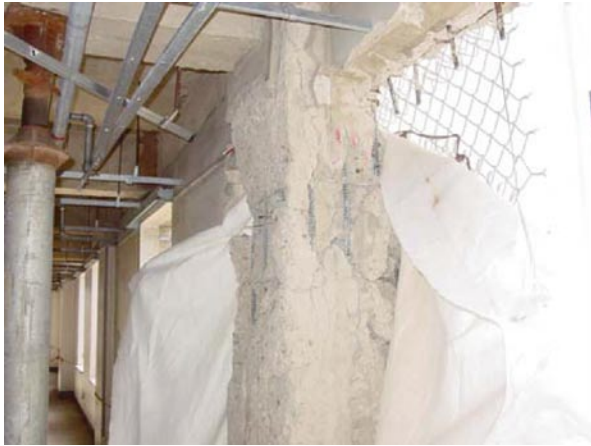
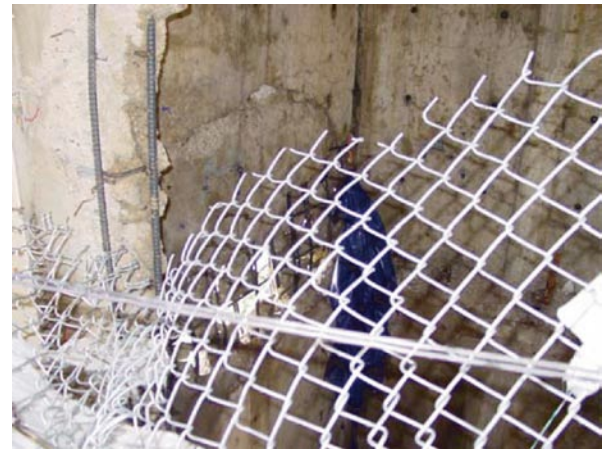
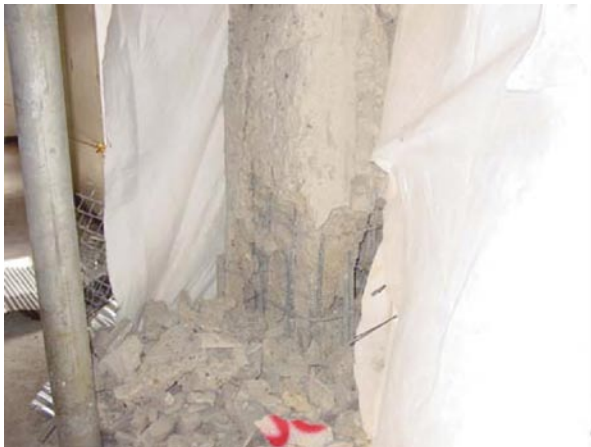
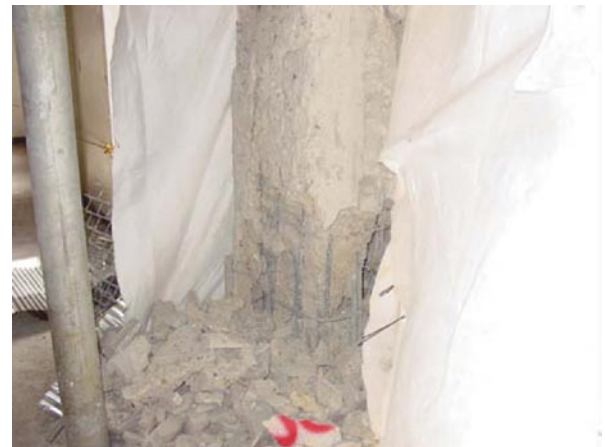
(a) The left inner wall

(b) The right inner wall

Fig. 8 Results of demolition after the test blasting of the pillar part.

The results of demolition of the pillar part after blasting are as shown in the Fig. 8. For pattern 1, the results for the upper part of the pillar were very poor. For pattern 2, the results for the lower part of the pillar were a little insufficient. It is estimated that the reason for these results was the strong resistance of the reinforcing rod due to the fact that the intercostals muscles of the central part of the pillar were located in a 30 cm interval which is narrow compared to the general 60 cm interval. For the case of pattern 2, although the demolition effect was not satisfactory, it can be said that it was close to the appropriate amount of explosive because a cumulative effect of 3 blasting holes can be expected in the main blasting.

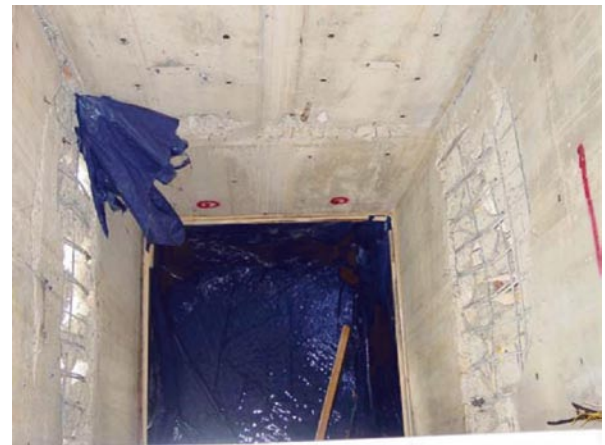
(c) Inside as a whole

Fig. 9 Results of demolition of the elevator room test blasting.

As shown in Fig. 9, the result of the water pressure blasting was poor in each side wall, the wall opposite to the opening part and also in the whole area. Therefore it is estimated that in the main blasting an increase in the amount of explosive is required as in the case of the pillar part.

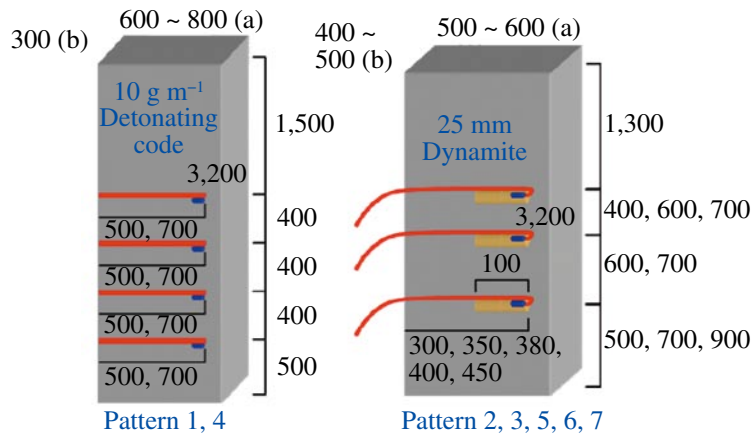
Fig. 10 Specific location of charge in the pillar part.

maximum amount of explosive per delay 0.93 kg / delay, amount of explosive per hole 0.0625 kg / hole Fig. 10 shows the typical explosive location pattern .

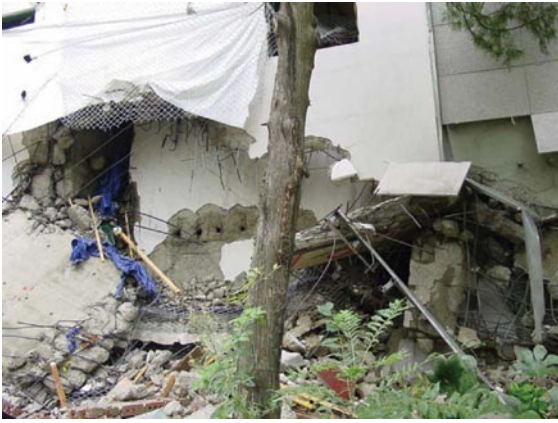
Fig. 14 Picture after blasting of the elevator room.

The demolition situation of the elevator room after the blasting is shown in Fig. 14. As shown in this picture, the elevator room was demolished totally without having any influence on the total demolition behavior of the structure.
